Chicago, Illinois  
May 2-7, 2010

Paper A-1-04

## OCEAN OUTFALL PRESENTS CHALLENGES TO HDD CONSTRUCTION

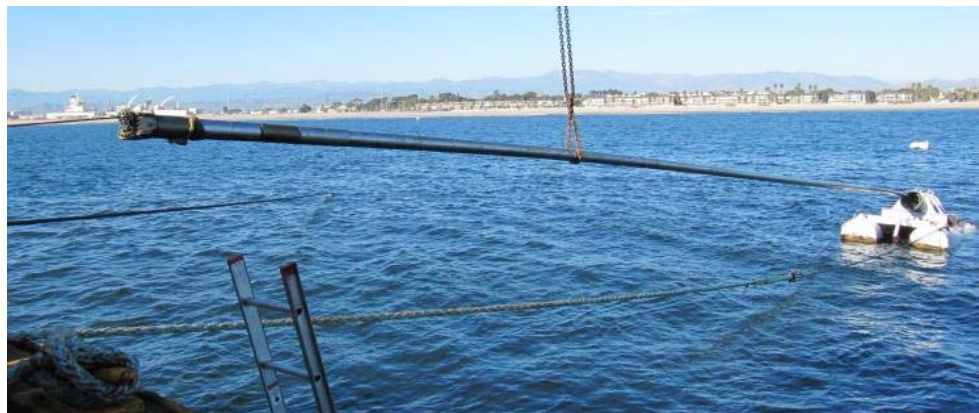
**Figure 7. Drill string suspended between derrick barge and pontoon**

The drill string exited into the dredged trench and was maneuvered by divers up out of the water and onto a pontoon boat anchored alongside the barge. The pontoon was used to support the midsection of the span as the drill string was pulled toward the barge. The driller began advancing the drill string a little bit at a time while the derrick crane slowly pulled up on the drill bit and the winch on the deck pulled the pipe toward the barge (Figure 7).

Initially the drill bit was exiting the water at about a 30 degree angle, which was too steep to secure to the deck without damage to the pipe. The crew was able to reposition the rigging supporting the drill string farther back down the pipe to

improve the exit angle, and managed to get the borehole assembly secured to the deck of the barge where it was removed from the drill string.

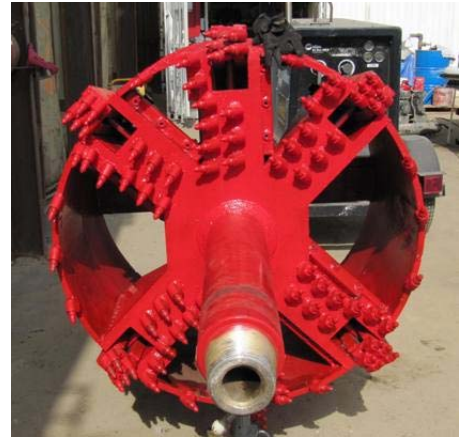
**Figure 8. 45-inch reamer with expanding teeth**

A 45-inch fly cutter with 2.5-inch hydraulically expanding cutting teeth (shown in Figure 8) was used for the second reaming pass which began on October 27<sup>th</sup>. With teeth fully extended the 50-inch reamer (size with teeth expanded) was installed at the drill rig and forward reamed using the barge winch to pull on the drill string while the rig applied torque to rotate the reamer. However, the expanded teeth were damaged upon reaching the end of the 54-inch conductor casing. While pumping mud at low pressure and carefully monitoring for signs of settlement, the Contractor began rotating the reamer in an attempt to mill out the end of the 54-inch casing. The drill string had some problems with rotation but managed to get past the casing. No signs of settlement were observed.

After 300 feet of drill string had been advanced, reaming was stopped to break a section of drill pipe off on the barge and reinstall the swivel and cable. Reaming continued smoothly until DP #15 when viscosity of the mud began to noticeably decrease and spoils coming off the mud tank separators turned from larger cohesive pieces to clays and ultrafine-grained material. Reaming continued, but the mud was not viscous enough to hold suspended spoils and had too much fine content to separate out at the tank. New mud was mixed and reaming continued slowly, with new mud being constantly made to keep the velocity up. Additionally, the derrick barge was having difficulties developing enough tension on the drill string and the rotary torque was slowly increasing. By DP #37 the rotary torque had increased beyond the capacity of the drill rig and the Contractor had decided to trip the reamer back to the entry point.

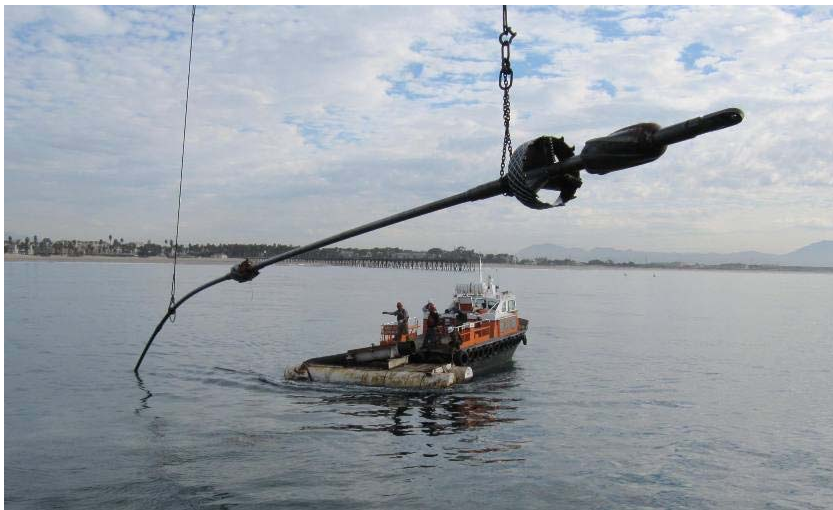
**Figure 9. 48-inch reaming assembly exiting to the derrick barge**

complete and the reamer was tripped back to the barge (Figure 9).

After the multiple failed attempts at the larger diameter, the Contractor elected to try forward reaming a 32-inch fly cutter, this time successfully completing the ream to the exit pit with adequate slurry returns and low rotary torque throughout. After removal onto the deck of the derrick barge, the 32-inch reamer was broken off the drill string and replaced with a new reaming assembly consisting of a 48-inch fly cutter, 29-inch centralizer and 36-inch barrel reamer. The back ream began at the exit pit with DP #75 and advanced all the way to DP #31 with no slurry returns observed at the entry. At this point reaming was considered

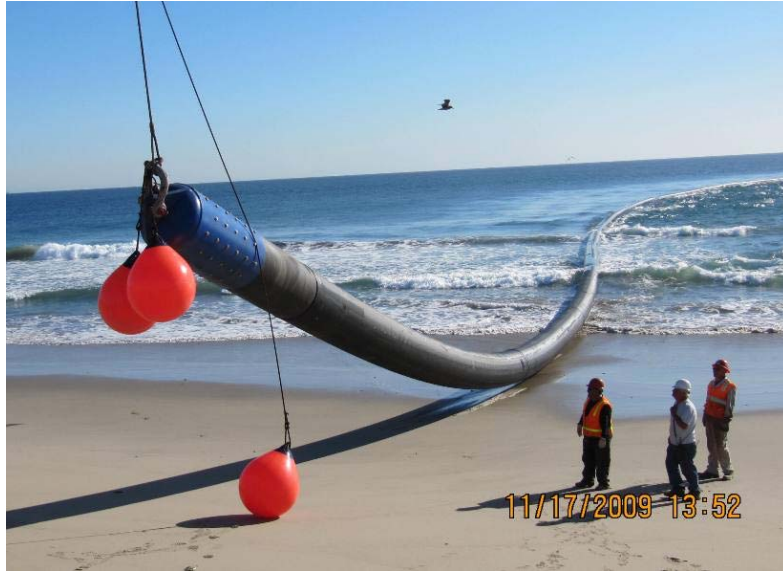
**Figure 10. HDPE pipe heading out to sea from Pt. Mugu**

buoyancy. Meanwhile, pull loads were approaching 75% of the capacity of the pipe. The Contractor began pumping water into the offshore end of the pipe and pushing down with the 24 ton dredge bucket to sink the pipe in front of the exit pit. Pullback pressure began to drop substantially and was at 25% of capacity by DP #55. Intermittent returns were noted at the entry point starting around DP #44.

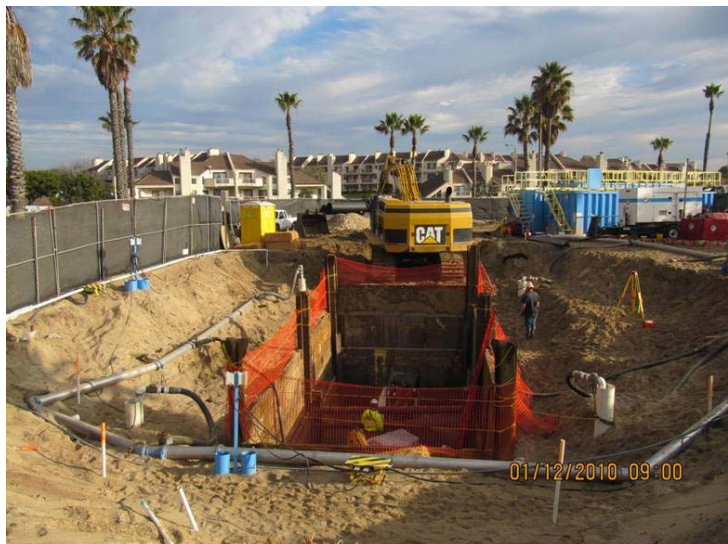
**Figure 11. Excavation to expose pull head**

Pullback proceeded smoothly up until DP #4 at the end of the 54-inch conductor casing. The drill string was pushed forward and backward in an attempt to work the swab barrel through the end of the casing but was met without success for over two hours. Pull forces were so high that the supports between the rig and the casing sheared off and the rig moved several feet toward the entry pit. The Contractor tried inserting 100 feet of 18-inch centralizer casing in an attempt to centralize the barrel within the 54-inch casing, but with no effect. Pullback was halted on November 18<sup>th</sup> with the pull head within 90 feet of the entry pit.

However, once the pull head was exposed it was discovered that the pipe was too far out of alignment to be connected within the excavation at the end of the conductor casing. The last 90 feet of 36-inch diameter HDPE product pipe was eventually installed via open cut in February of 2010.

After considerable discussion with the Owner, the Contractor exposed the pull head and swivel inside a slide rail shoring excavation at the end of the conductor casing (Figure 11).
