Orlando, Florida
April 24-27, 2005

STARTING OFF ON THE WRONG FOOT - PROBLEMS WITH MICROTUNNELING SHAFTS

Bruce Harbin¹, MSc., P.E., Matthew Wallin¹, MSc., P.E., David Bennett¹, PhD, P.E.,
Kimberlie Staheli², MSc, P.E.

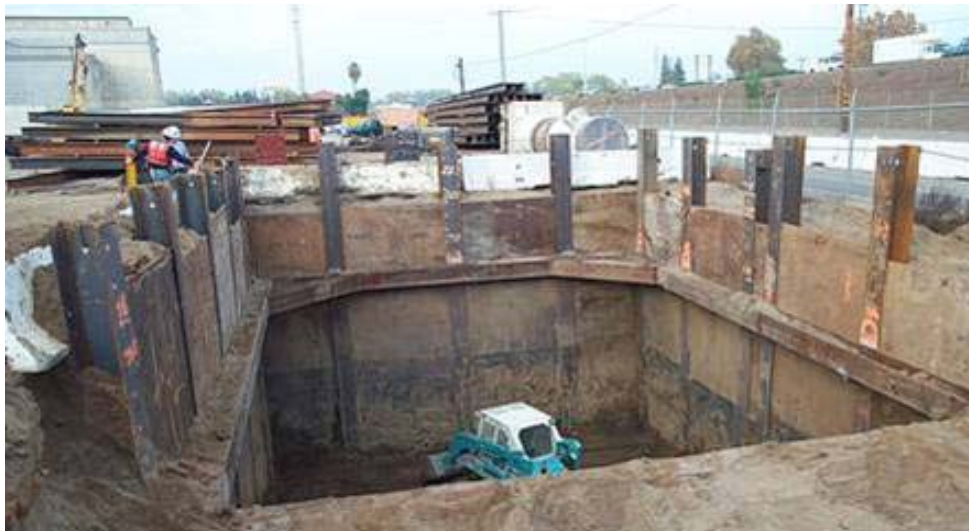
Figure 1. Soldier pile and steel plate lagging shaft used on an Interstate crossing

A soldier pile and lagging shaft is constructed by either driving, or pre-drilling and grouting in place, steel H-piles at a predetermined spacing and to a designed depth, prior to excavation. Once the soldier piles are in place around the perimeter, excavation of the shaft begins. As the excavation progresses, lagging (typically timber or steel plate) is placed between the soldier piles and pushed or driven to the bottom of the excavation to prevent soil from sloughing into the shaft as the excavation is advanced. Wales and struts are placed around the inside perimeter as necessary during the excavation progress to support the soldier piles, preventing deflection of the shoring due to external soil pressure as shown in Figure 1. Alternatively, on very large excavations tiebacks can be installed to anchor and support the shaft. Once the excavation is complete and the lagging or sheets are fully in place, wedges are driven between the lagging and the flanges of the soldier piles creating positive contact between the lagging and the soil. Pea gravel or contact grout may be placed behind the lagging to fill any void space. Finally, the shaft bottom is finished with a concrete working slab, or a layer of crushed rock, depending on the application and specification requirements.

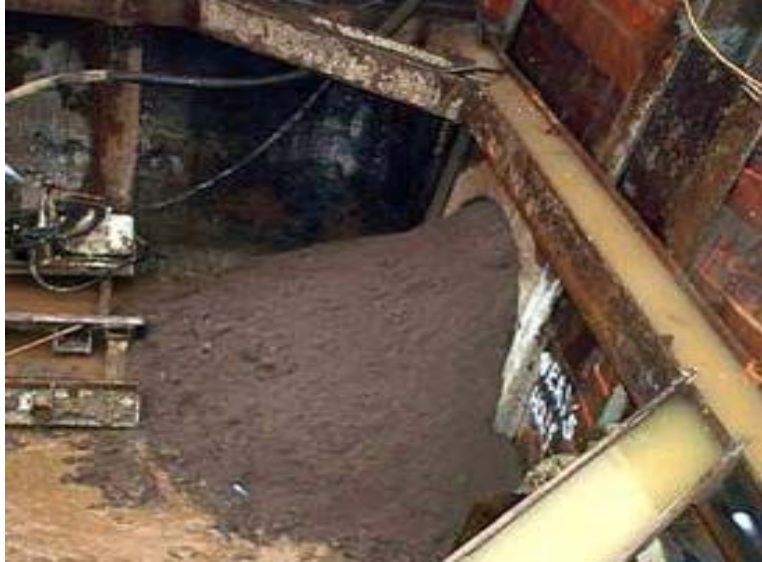
Figure 2. Loss of approximately 10 cubic yards of soil into the soldier pile and lagging shaft during cutting of portal for launch of MTBM

Finally, the jacking frame was set and the microtunneling subcontractor was ready to cut a portal in the steel lagging and begin the drive. However, when the 76-inch hole was cut in the lagging sheet, approximately 10 cubic yards of sand that had been loosely placed by the general contractor after the sloughing failure, came pouring into the shaft (Figure 2). The microtunneling subcontractor had to remove the sand, jack the MTBM through the launch seal out into the void outside the shaft, and then replace the sand in the void. This time the sand was compacted as it was backfilled around the MTBM. The sloughing event cost the Contractor a day of work. If the soil had not been so dramatically disturbed during shaft construction, and had the contractor driven the lagging ahead of the excavation, there would likely have been only minor sloughing that would have been easy for the crew to handle, avoiding a day of delay. If a soldier pile and lagging shaft were used again in these conditions, it would be wise to specify soil improvement at the exit location and have full-time construction inspection during shaft construction. Specialty inspection is essential to ensure that the shaft contractor follows sound construction practices to avoid excessive disturbance on the outside of the shaft and to require the contractor to properly compact any material placed around the shaft perimeter to repair any over-excavation. On this project, soil improvement using permeation grouting would have been very effective in the clean sandy soil and would have prevented any soil movement during break-out.

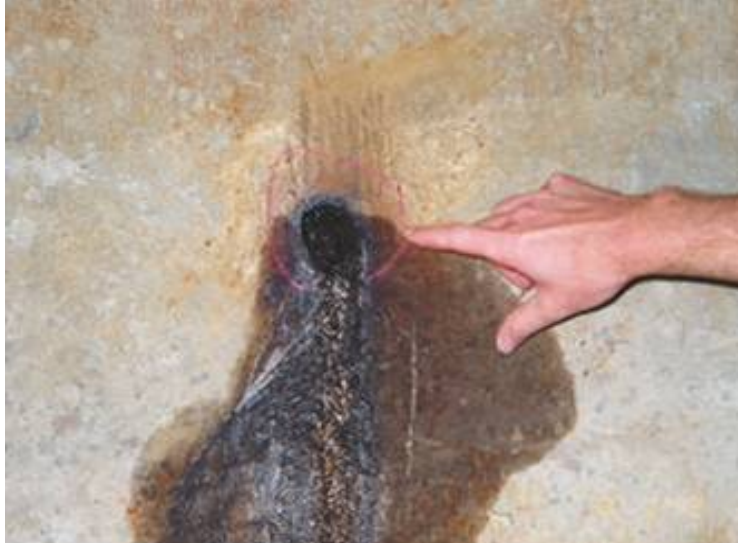
Figure 3. Soil stability checked by cutting small holes in steel plate prior to cutting full sized portal for MTBM launch or retrieval

On the owner's side of the project, on-site inspection during the construction of the shaft may have prevented the soil failures into the shaft, or at least made the problems known to the microtunneling subcontractor who could then have initiated grouting before the first drive. Additionally, in hindsight, the design team should probably have specified that ground improvement and stability checks be used at the break-out locations to prevent any sloughing of soil when the MTBM was launched. For example, before cutting the full-sized hole for the MTBM, a small hole should first be cut to evaluate stability as shown in Figure 3. If raveling or running began, then ground improvement would be required. Successively larger holes would then be cut to evaluate stability before the full size hole was cut.

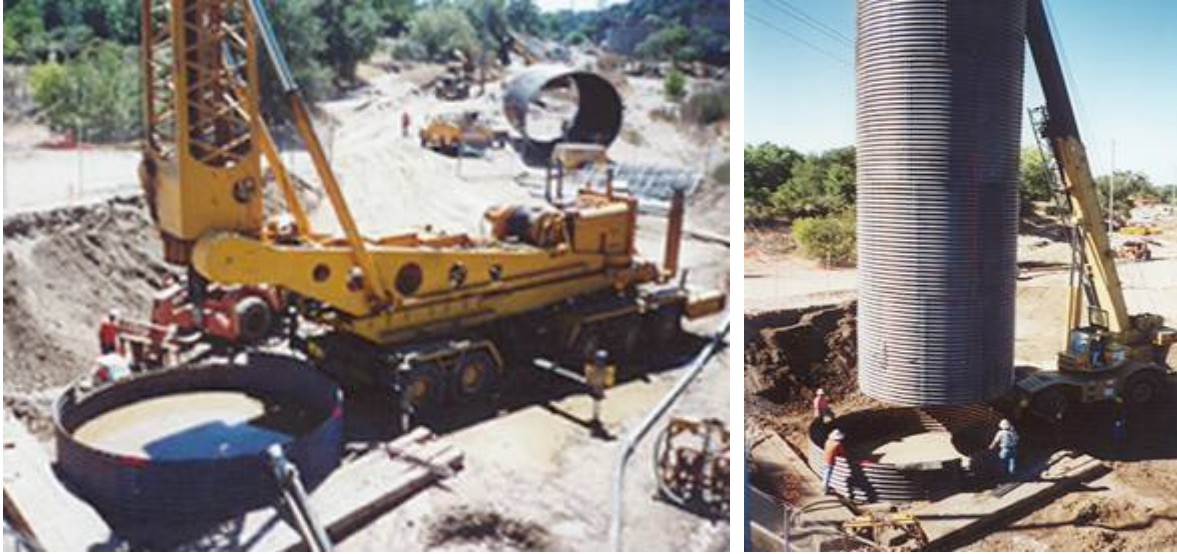
Figure 4. Large diameter auger-drilled reception shaft constructed for a microtunneled drive adjacent to a river

2. Fabricate a starter or outer corrugated metal casing by bolting together curved panels or segments.
3. Enlarge the pilot hole using reaming wings and a muck bucket. For deep shafts, the reaming process may be completed in two or more stages with each stage including the setting and grouting of telescoping casings, as shown in Figure 4.

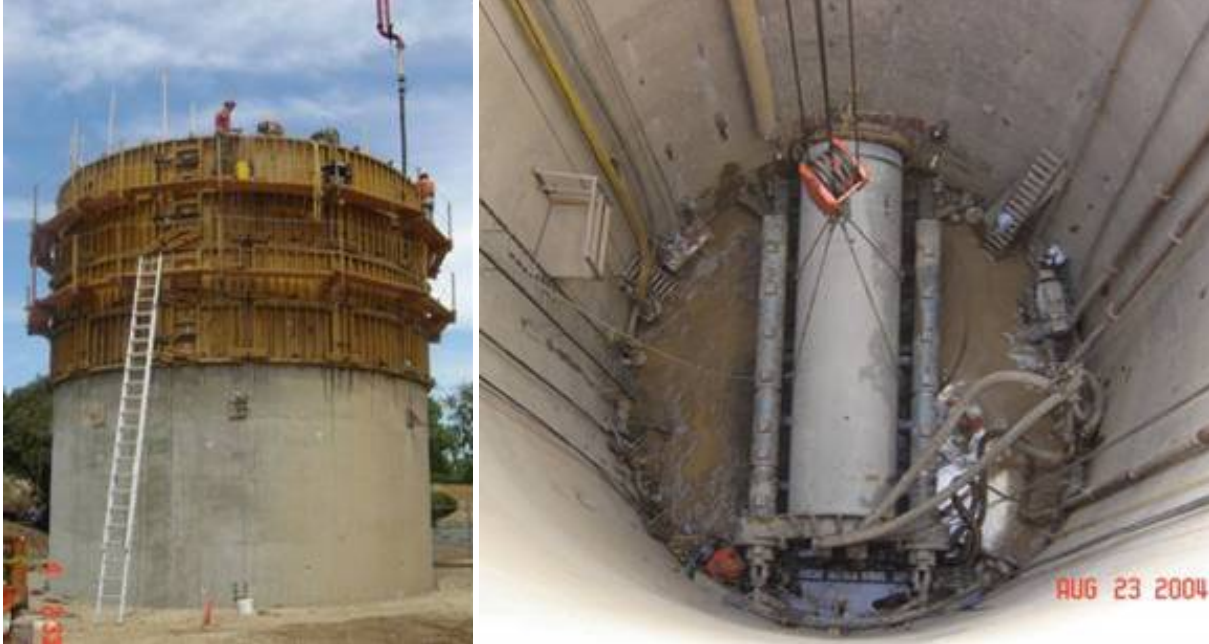
Figure 5. Concrete caisson shaft during construction (left) and being used as a jacking shaft (right) for river crossing projects

Typically, a caisson is cast in 8 to 20 foot lifts, with a cutting shoe fabricated of steel at the base. When the first lift of concrete has cured sufficiently, the forms are stripped and excavation begins inside the caisson. The caisson sinks under its own weight as the soil inside is excavated. When the caisson reaches design depth, a tremie plug is cast to resist uplift and boils, and the caisson may then be dewatered. Figure 5 shows a concrete caisson during construction and once constructed being used as a jacking shaft.

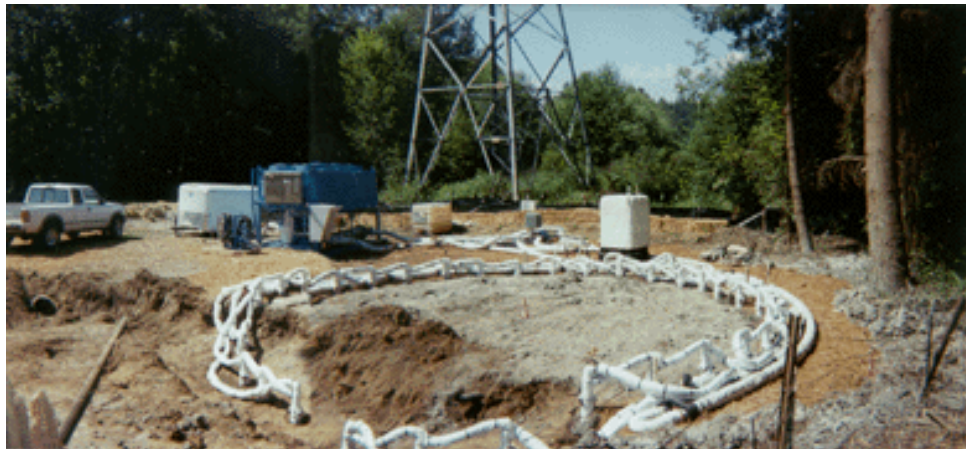
Figure 6. Cooling pipes freezing groundwater prior to shaft excavation (www.cryocell.com)

Ground freezing can be used to construct shafts by freezing the in-situ groundwater which bonds with the soil to form a solid soil-water matrix that is impermeable to water. Freeze shafts are created by drilling and installing small diameter (typically 1 to 2-inch) pipes to the desired shaft depth around the perimeter of the shaft to allow for circulating the cooling medium as shown in Figure 6. Typically a brine solution is used as the cooling medium, although if rapid freezing is required, liquid nitrogen can be used at a significant cost penalty. The cooling medium is housed in a refrigeration unit and circulated through the piping system. Over time, ice columns build around each of the freeze pipes. The cooling medium is continually circulated through this closed loop system until the ice columns “grow” together forming the desired shaft wall thickness. This process can take several weeks or even a few months, depending on the ground conditions. In addition, it is important to note that if groundwater velocities are relatively high, it may not be possible to establish a freeze. Therefore, it is extremely important to have a geotechnical engineer with ground freezing experience evaluate the insitu soil and groundwater conditions prior to attempting ground freezing techniques.

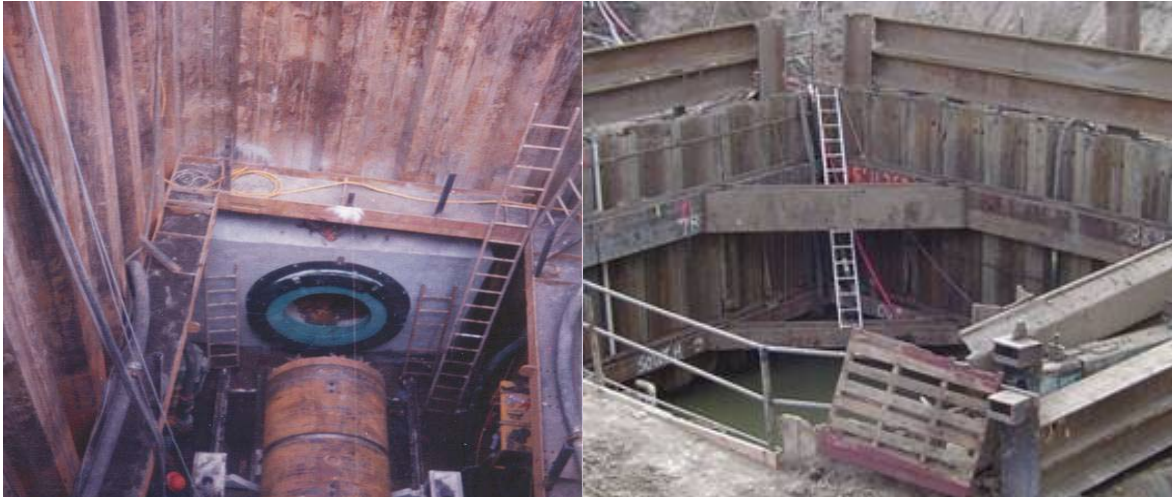
Figure 7. Sheetpile jacking shaft prepared for launch of the MTBM (left) and a shaft that flooded during construction with split interlocks allowing high inflow of water (right)

When steel sheetpiles are used in areas of high groundwater it is extremely important to keep the sheets interlocked during placement. If the sheets are driven too far ahead of each other, the interlocks can split during installation and the seal will be compromised. Additionally, if the soil contains large amounts of gravel, it may be difficult to maintain the interlock during installation as rocks can get into the socket and disrupt the jointing. Interlocking is also very difficult to achieve in soils with cobbles and boulders present, and is generally not recommended. Even in soils without rocks, it is often not possible to make the interlock between the first and last sheets due to spacing issues. Any corners that cannot be properly interlocked need to be sealed after excavation by welding a patch panel of steel between the adjacent sheets.
