INVERTED SIPHON INSTALLED FROM ALAMEDA TO OAKLAND USING HDD

Kimberlie Staheli, P.E., Principal, Bennett / Staheli Engineers
Glenn Hermanson, P.E., Project Manager, Bennett / Staheli Engineers
Pam Hopkins, P.E., Construction Manager, East Bay Municipal Utility District
Craig Vandaele, Construction Inspector, Bennett / Staheli Engineers

ABSTRACT

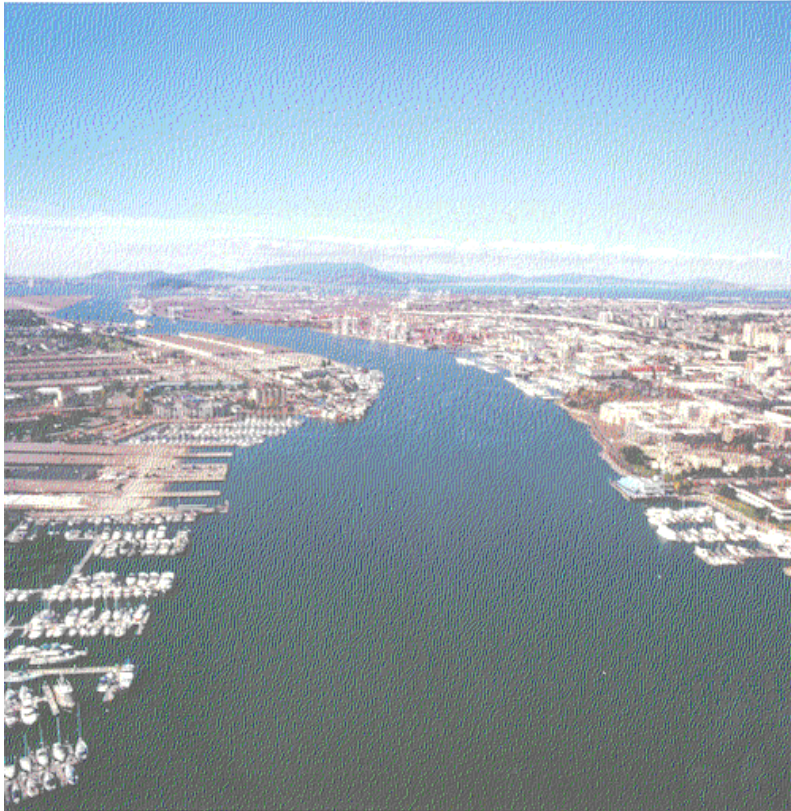
Figure 1 Alameda Channel

The heavily traveled Alameda channel in the Port of Oakland is scheduled for dredging to increase necessary channel depths. However, the scheduled dredging operations will remove the existing force main from Alameda to Oakland. The sewage currently being conveyed by the force main was re-routed to the south where it connected into an existing EBMUD interceptor that crosses the Alameda Channel through an existing two-barrel inverted siphon. A third barrel was required in order to convey this additional flow.

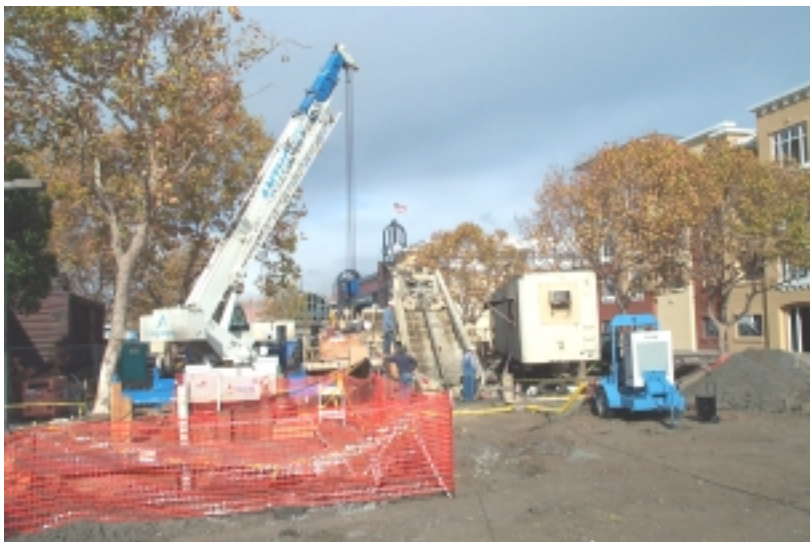
Figure 2 Rig-Side Equipment Layout -- Oakland

The first equipment arrived at the site on October 12, 2000. The drill rig was located on the east side of the channel in Oakland. The drill operation would progress beneath the Alameda channel to the west, exiting in Alameda. Mobilization required four days. A TruTracker system was

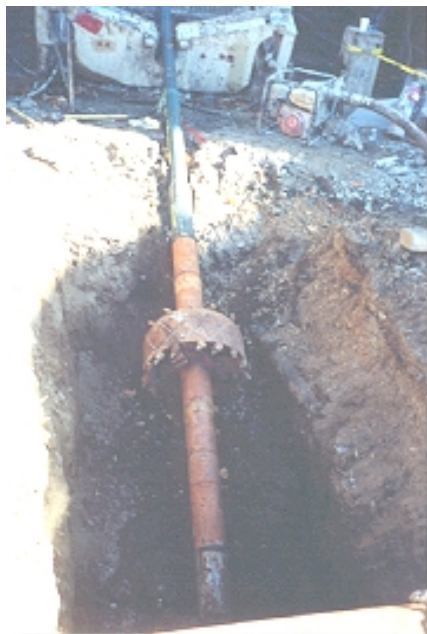
Figure 3 28-inch Fly Cutter

28-inch Reaming Pass. On the first reaming pass, a 28-inch fly cutter was used to enlarge the pilot bore. There was some concern that the reamer might encounter the object that caused the pilot bore to deflect; however the contractor reamed past that location without incident. When the reamer was approximately 300 feet into the bore, drilling mud circulation was lost and

inadvertent returns were observed on the east side of the channel. The contractor elected to pull the drill rods in an attempt to seal the hole and re-establish circulation. The driller believed that the open portion of the fly cutter was plugged with clay, allowing the pressure to build up in the bore and mud to escape to the surface rather than returning to the mud pit. The contractor was able to re-gain circulation and decided to bring the marsh funnel viscosity of the mud down to help facilitate removal of the excavated material. This plan was successful and on the second day of reaming 28 drill pipes (approximately 840 feet) were installed.

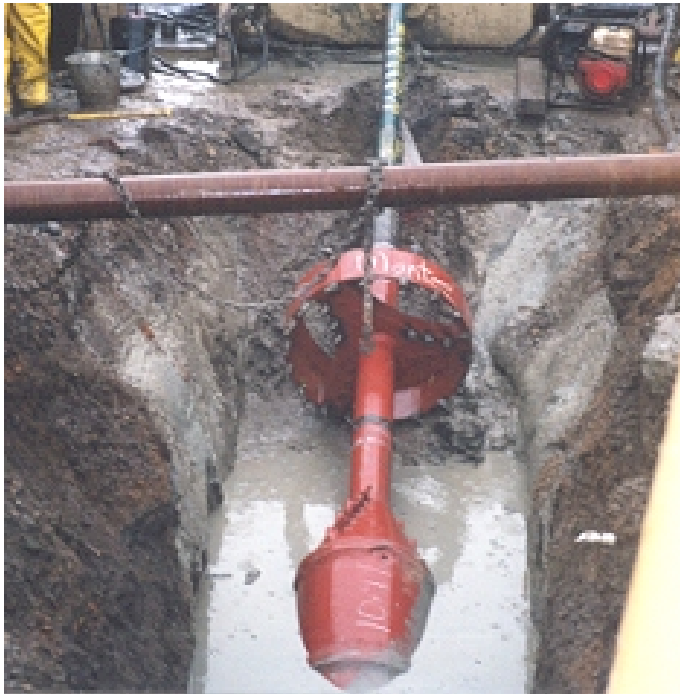
Figure 4 Second Reaming Pass

36-inch Reaming Pass. The second pre-reaming pass was conducted with a combination of a 20-inch barrel reamer followed by a 36-inch fly cutter. The 20-inch barrel was used to keep the reamer centralized in the previously reamed 28-inch bore. Again, forward reaming operations

took place from the Oakland side of the channel to the Alameda side of the channel. The enlargement of the borehole to 36 inches generated a tremendous volume of mud that contained seashells. These shells would clog the sand cones on the mud plant. As a result, the mud plant was the limiting factor for the speed of the drilling operations. The reaming had to be stopped several times while the seashells were cleaned from the sand cones in the mud plant.

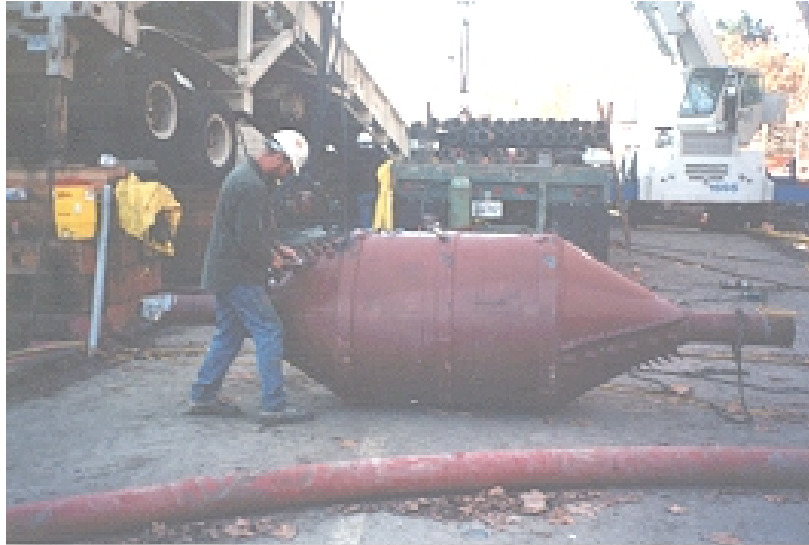
Figure 5 42-inch Barrel Reamer for Swab Pass⁷⁴

Swab Pass. Upon completion of the reaming operations, a swab pass was conducted prior to the pullback of the product pipe. The contractor used a 42-inch barrel reamer and forward swabbed

from Oakland to Alameda. The swab pass was completed in 8 hours and 20 minutes.
